BP Exploration (Alaska) Inc. (BPXA) - Corrosion Monitoring and Prevention Program

Overview - Oil Field Corrosion

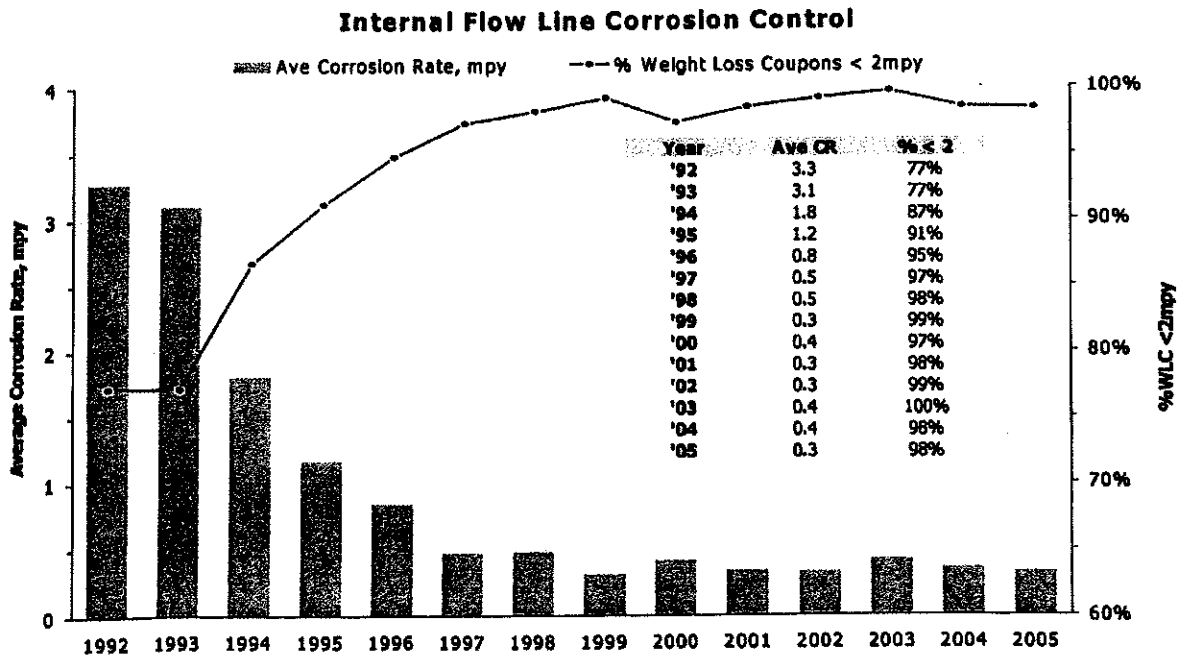
Most important, a substantial improvement in control of internal corrosion in three phase flow lines (i.e. pipelines that transport oil, gas and water) has been seen over the past several years. The following graph illustrates the significant improvement in corrosion rates experienced since the early 1990s and the effective management of the corrosion rate over the past ten years. This plot shows the average corrosion rate on major production flow lines.
